TESTING DISTRIBUTION SWITCHGEAR FOR PARTIAL DISCHARGE IN THE LABORATORY AND THE FIELD

Neil DAVIES
EA Technology Ltd. – UK
neil.davies@eatechnology.com

Simon GOLDTHORPE
EA Technology Ltd. – UK
simon.goldthorpe@eatechnology.com

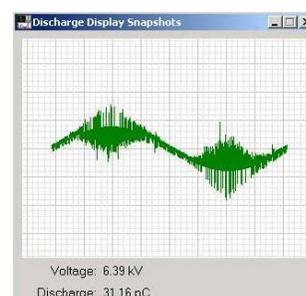
From extensive testing of switchgear with partial discharge tracking across the surface of insulation it has been observed that surface discharge activity often has low amplitude but very high discharge rate. An example of this can be seen in Fig.1 where surface discharge was occurring across the polymeric insulation of an 11kV circuit breaker.

Fig. 1: Surface PD activity on an 11kV circuit breaker. Low discharge amplitude, high discharge rate

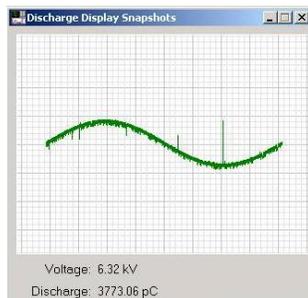
In contrast to surface discharges, internal void discharges as they develop will have consistently high amplitude levels but have much lower discharge rates. Fig.2 shows one example of PD measurement on a cast resin CT on switchgear operating at 10kV.

Fig. 2: Internal PD activity on a 10kV current transformer. High discharge amplitude, low discharge rate

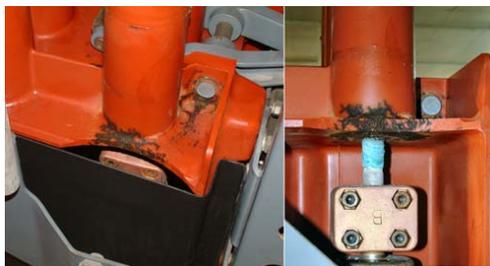
Fig. 3: Tracking on Circuit Breaker 16 months into testing White powder, verdigris and significant amounts of tracking

can easily be seen at the top of the red phase vacuum bottle and from the closest earthed metalwork. The discharge area was left untouched and the circuit breaker was put back into service and re-energised.

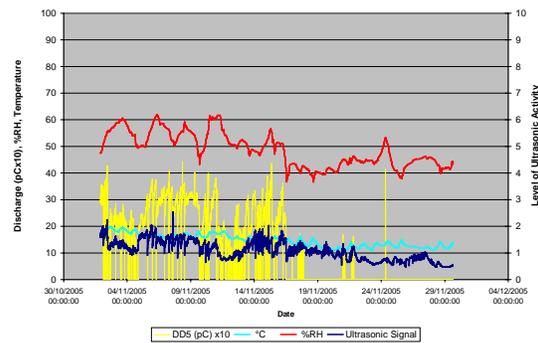
Somewhat surprisingly, Fig.4 shows that after the examination where the circuit breaker had been allowed to dry out and the humidity within the test environment was allowed to follow the natural profile, the level of discharge activity measured in pC dropped to very low levels and sometimes zero.

Fig. 4: Discharge Profile 16 to 17 months into testing

The level of ultrasonic activity correspondingly dropped with the reduction in partial discharge as the humidity naturally fell and remained below 50%RH; this despite the obviously degraded state of the primary insulation as shown in Fig. 3. Note, in Fig. 4 the base line for no detectable ultrasonic activity is a level of 0.5 on the secondary y-axis.

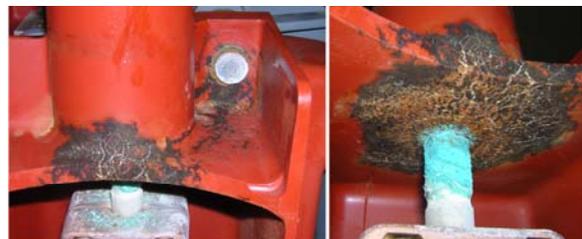
The test continued for another twelve months and again the circuit breaker truck was racked out and visually examined. During this examination, the cast resin monobloc appeared damp with moisture that was subsequently found to be nitric acid with a pH level of 3. The continuing very advanced path of partial discharge development between the top of the 'live' vacuum bottle retention clamp and the nearest earthed part can again be seen in Fig. 5. Comparison of Fig. 3 and Fig. 5 reveals how the treeing and tracking effectively advanced from the 'live' towards earth and the earth towards 'live'.

Fig. 5: Tracking on Circuit Breaker 26 months into testing Twenty-seven months after the start of the test, the circuit

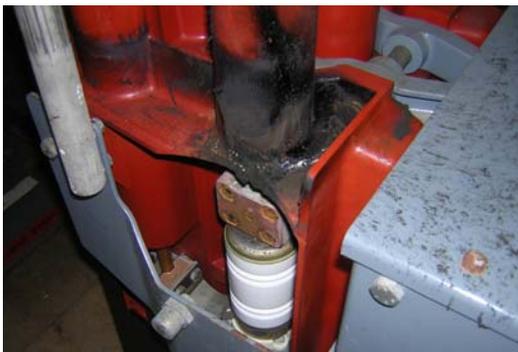
breaker was de-energised. When it was re-energised a short time later, it failed producing a substantial quantity of smoke and a large deposit of carbon and other material within the enclosure, Fig 6. Upon inspection, it was plain that the tracking had caused a low resistance conductive path and short circuit allowing the release of fault energy.

Fig. 6: Failure 27 months into testing
