# VisNet Hub Case Studies

This document shares practical examples of insights provided by monitoring the low voltage network. The data collected for these case studies was obtained by EA Technology's VisNet Hub.

# Using VisNet® Hubs to identify and locate large unusual loads on LV networks

# Using VisNet<sup>®</sup> Hubs to investigate power quality issues

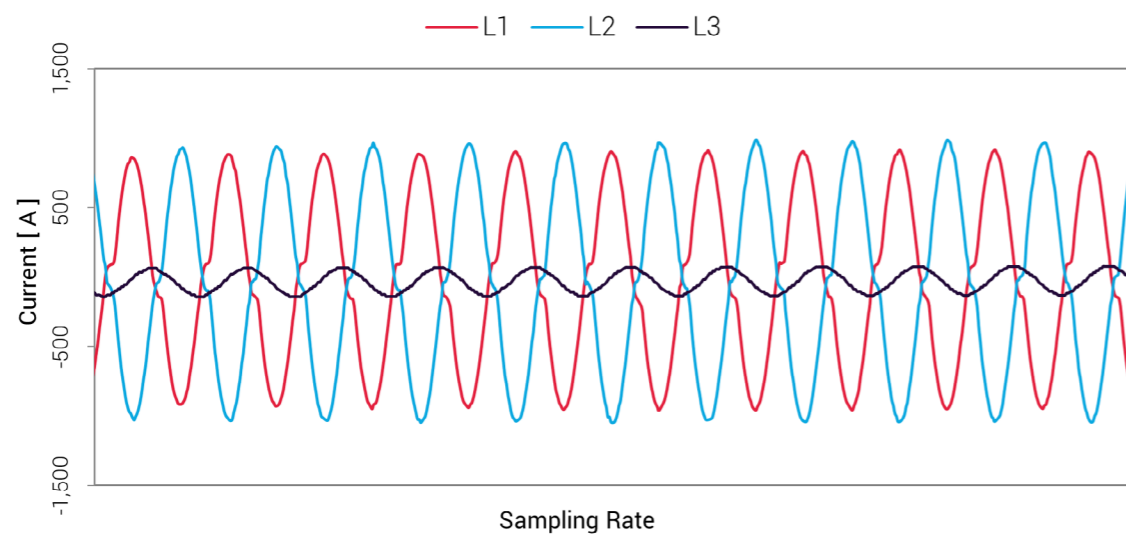
Figure 1: The current waveform of feeder 4 captured by VisNet. The 'L' labels denote the feeder phase measured.

Once installed, the VisNet Hub was able to continually monitor network data, and by configuring the waveform capture settings, we were able to automatically measure the number of irregular current events; this is graphed in Figure 1.

Within 48 hours, several hundred abnormal waveforms had been captured linked to phases L1 & L2 on network feeder No.4. Phase L3 represents nominal current values for that network for comparison. From analysis, the waveforms were being captured

every 10 seconds (on average) and the peak load drawn was in excess 900 A, but only for very short durations (less than 1 second). These events occurred exclusively during the working week, with no activity over the weekend. With these insights at hand, we could deduce that the source of disturbance was either the scrapyard, or one of the companies on the small industrial estate which were fed of the same circuit.

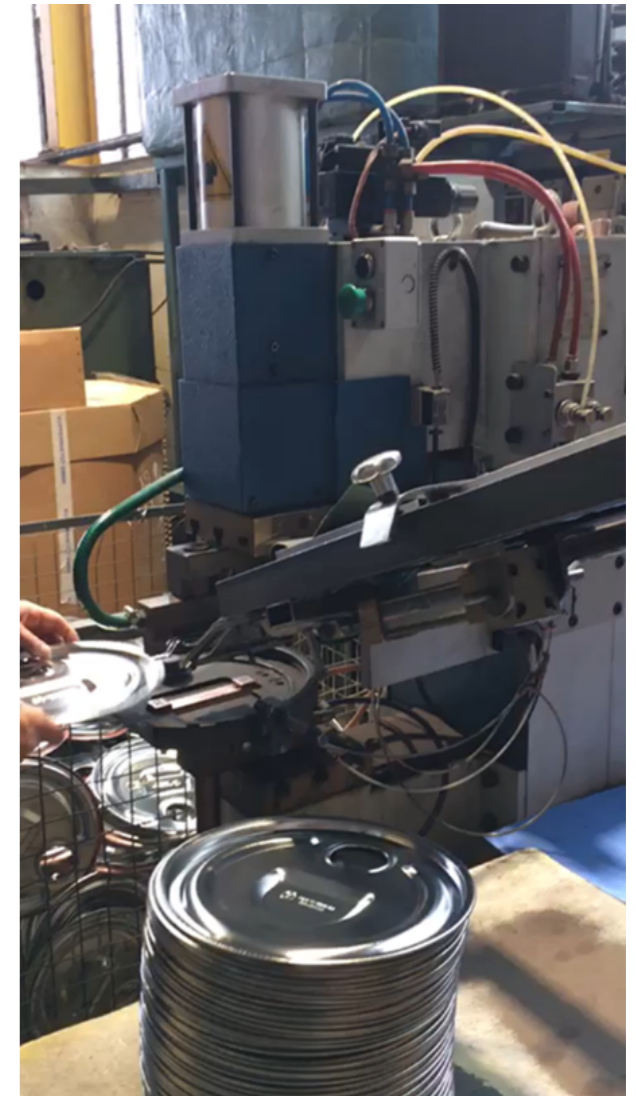
Figure 2: A spot welding machine used to weld handles on to metal lids

By a process of elimination and discussion with the relevant parties, we discovered that a small metal container manufacturer was the cause of the 2-phase unusual load on the network. The manufacturer was using a spot welding machine for attaching the metal handles onto the metal container lids, as shown in Figure 2.

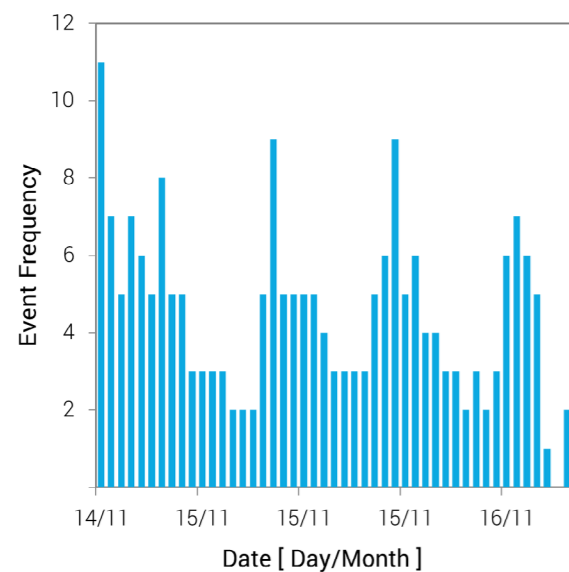
Figure 1: The frequency of irregular current events captured by the VisNet Hub.

Once installed, the VisNet hub was able to continually monitor network data, and by configuring the waveform capture settings, we were able to automatically measure the number of irregular current events; this is graphed in Figure 1.

By examining the data, we were able to determine that the incident affecting the network occurred routinely (approximately 5 times an hour on average). We also learned that this was a three-phase issue. By inspecting the current waveform (shown in figure 2), we

found that the events coincided with an inrush of current (typically five times nominal values), which is commonly associated with the start-up of large machines. From Figure 1, we can also see that the peak current values steadily decrease with time. This is characteristic of a motor powering-up and then reaching steady state.

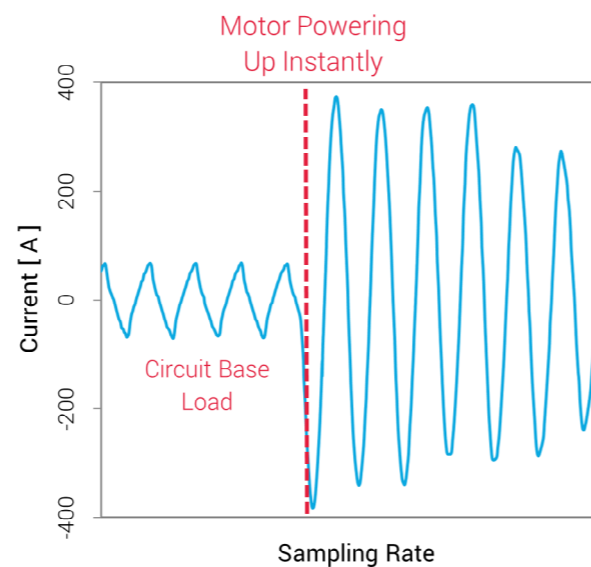
Figure 2: The network current before and after the motor powered up with a direct on-line setting (instantly). This waveform coincided with the events shown in Figure 1.

With these insights at hand, the team took a closer look at the cable records and identified a previously overlooked water pumping station connect to the LV network. The network operator, with help from EA Technology, was then able to identify and locate the water utility to carry out repairs within 24 hours. We found that the issue originated from a pump motor powering up. The “soft start” mechanism designed to limit the start-up current had failed to operate correctly and instead reverted to direct on-line starting; this was causing a large start-up current to be drawn leading to the dimming of lights.

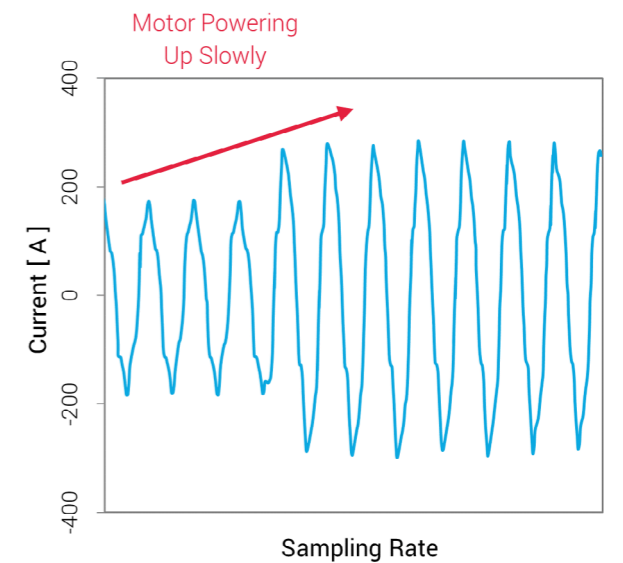
Figure 3: The network current before and after the motor powered up with a soft start setting (slowly).

With the VisNet installed, we can continuously monitor the pumping station to ensure that current bursts are within tolerable limits. Figure 3 shows the current waveform after repairs had taken place. As you can see, the peak currents reached are less than previously recorded with no detrimental effects on domestic lighting.

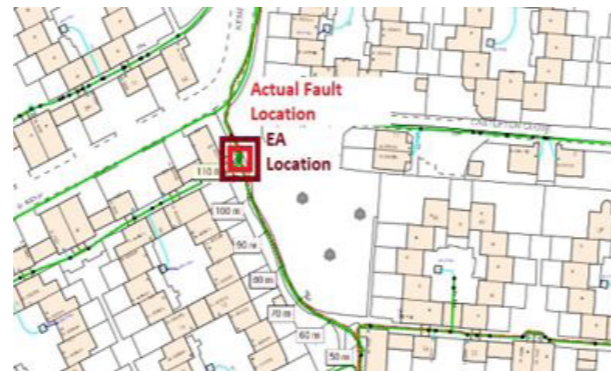
An example of predicted and measured fault location

The network cable records provide the geometry, length, and type of LV cables, enabling us to map an impedance-to-fault measurement directly on to the records. The result of which estimates how far the fault is down the cable. By comparing this length to the geometry of the cable, we can estimate the location of the fault; this is demonstrated in the figure above.
