After the flood

How to prevent future failures and outages
after the immediate damage is fixed

Averting post-flood failures

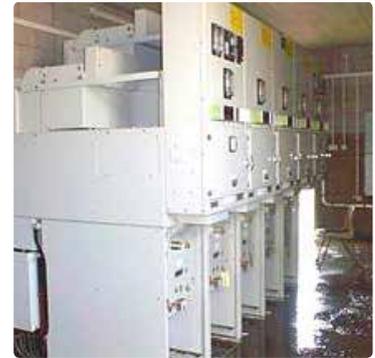
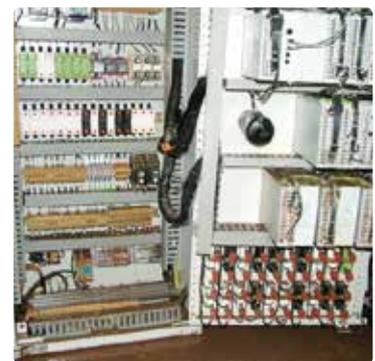
Internal corrosion was visibly developing on this unit, just 24 hours after flooding

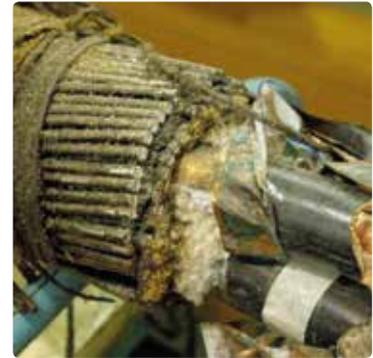
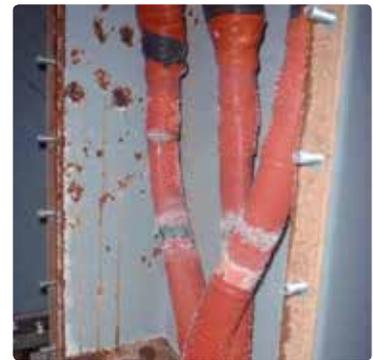
Moisture and contamination can cause problems to develop long after immediately apparent flood damage has been fixed.

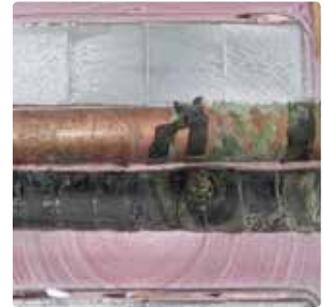
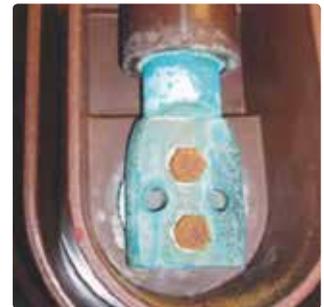
Flood-induced corrosion can continue to develop on many components.

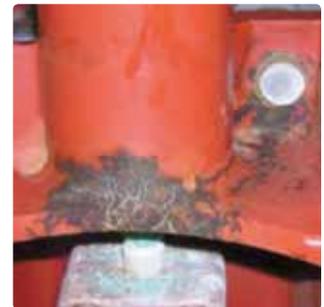
The effects of corrosion (top) on a circuit breaker, 26 months after moisture contamination and (bottom) on relay contacts. Damage is clearly leading to failure.

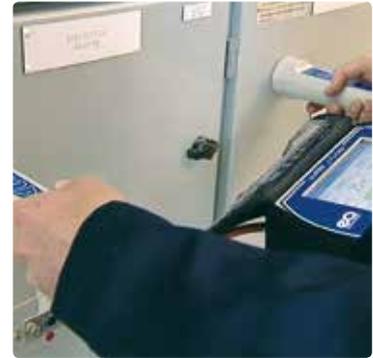
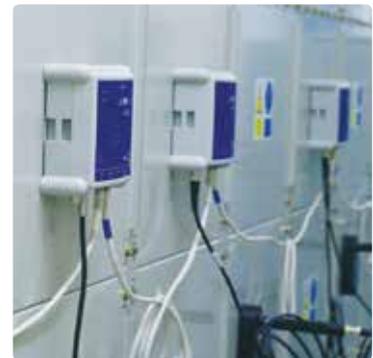
Ongoing measurement, location, recording and analysis of partial discharge activity will help identify post-flood defects that could escalate into failures.

The UltraTEV Locator™ (top) and UltraTEV Monitor™ (bottom) both measure relative humidity, as well as surface and internal discharges.

Immediately after energising, all medium voltage equipment should be checked for the presence of partial discharge activity, utilising ultrasonic sensors to detect surface problems and TEV sensors to detect internal component or apparatus flaws. A PD survey should be conducted weekly for the first month and quarterly for the first year. For more critical assets consideration should be given to installing permanent monitoring equipment.
